DEPARTMENT OF TRANSPORTATION

Contract #: 04-0120F4Cty: SF/ALA Rte: 80 PM: 13.2/13.9File #: 1.28**WELDING INSPECTION REPORT****Resident Engineer:** Casey, William**Address:** 333 Burma Road**City:** Oakland, CA 94607**Report No:** WIR-026474**Date Inspected:** 05-Oct-2011**Project Name:** SAS Superstructure**OSM Arrival Time:** 700**Prime Contractor:** American Bridge/Fluor Enterprises, a JV**OSM Departure Time:** 1530**Contractor:** American Bridge/Fluor Enterprises, a JV**Location:** Jobsite**CWI Name:** As noted below**CWI Present:** Yes No**Inspected CWI report:** Yes No N/A**Rod Oven in Use:** Yes No N/A**Electrode to specification:** Yes No N/A**Weld Procedures Followed:** Yes No N/A**Qualified Welders:** Yes No N/A**Verified Joint Fit-up:** Yes No N/A**Approved Drawings:** Yes No N/A**Approved WPS:** Yes No N/A**Delayed / Cancelled:** Yes No N/A**Bridge No:** 34-0006**Component:** SAS OBG**Summary of Items Observed:**

Quality Assurance Inspector (QA) Douglas Frey was at the American Bridge/Fluor (ABF) job site at Yerba Buena Island in California between the times noted above in order to monitor Quality Control functions and the in process work being performed by ABF personn

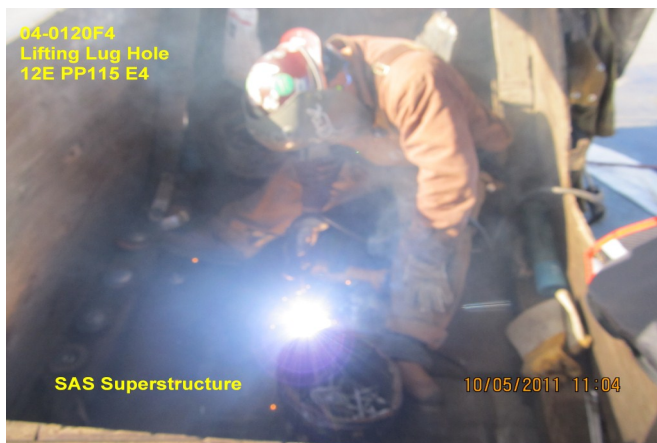
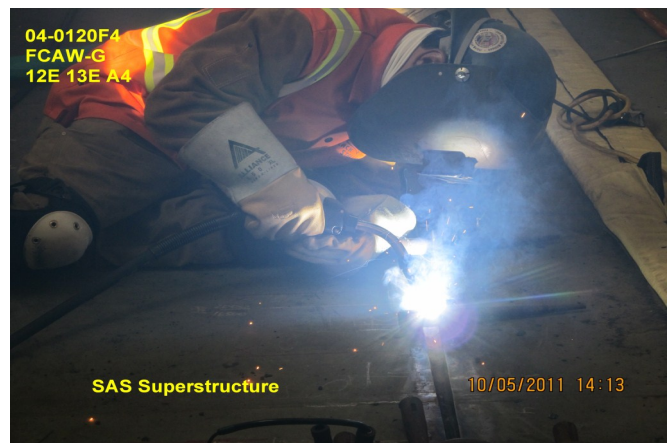
The QA inspector observed ABF welder Jorge Lopez ID# 6149 performing Shielded Metal Arc Welding (SMAW) in the 1G flat position on Lifting Lug Hole (LLH) #1 located at 12E PP115 E4. The QA inspector verified the fit up of the joint and found it to be satisfactory. The QA inspector observed the QC inspector identified as Fred Von Hoff monitoring the progress to ensure the welding parameters were in compliance pertaining to ABF-WPS-D15-1050A-CU.

In conjunction with QC William Sherwood this QA performed a visual survey of joint fit-up for the 35mm thick section of the "D" bottom plate of 12W/13W segment splice. Taking measurements at locations between open rib stiffeners with an iGauge digital caliper gauge it was observed that the root opening varied between 10.5mm ~ 15mm. The bevel angle measurements were taken from both the 12W and 13W plates and were found to range from 180 ~ 380.
